**Curly-leaf Pondweed P/I and Bed Mapping Surveys  
Apple River Flowage -WBIC: 2624200  
Polk County, Wisconsin  
May 16-18, and June 6, 8, 2011**

**Survey Conducted by and Report Prepared by:**

Endangered Resource Services, LLC  
Matthew S. Berg, Research Biologist  
572 North Day Road  
St. Croix Falls, Wisconsin 54024

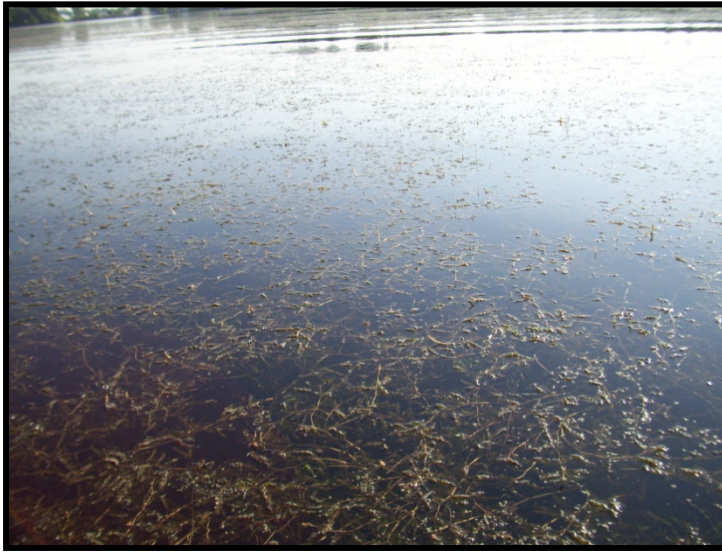
Typical Canopied CLP Bed on the Apple River Flowage (Berg, 2011)

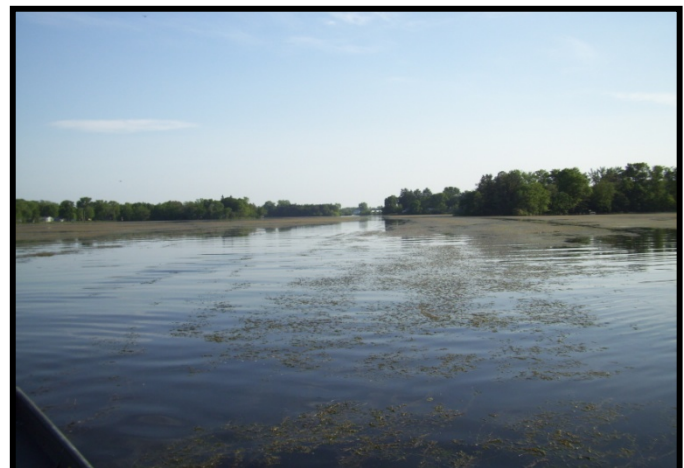
River Channel Through CLP Looking Towards the Dam (Berg, 2011)

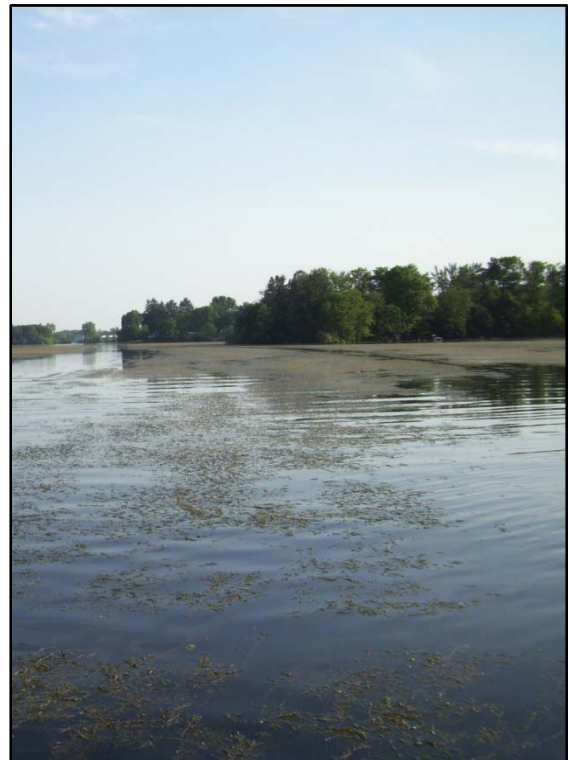
**Figure 5: City of Amery – CLP Beds 1 – 2**

**Bed 1** – The biggest bed on the Flowage, Bed 1 was dense, canopied, nearly monotypic throughout, and a major obstacle to any kind of recreation. The channel allowed travel through the area in May, but, by June, the only trails through were those that had been made by repeated boat travel by locals trying to access the channel. Most people appeared to avoid the area altogether as we observed numerous pontoons and boats turning around once they reached the north end of the bed. The only open water was nearest the dam, in a few deep areas over 8ft, and near the Beaver Brook Inlet where sand bottom areas proved unsuitable for CLP (Figure 5).

**High Density Area 1** – This bay had little CLP during the Point Intercept Survey in May, but many 10m<sup>2</sup> clusters had appeared by June. Although not filled in to form a technical “bed”, CLP was common throughout; especially near the south entrance to the bay. Coontail was especially thick on the north end, and this, coupled with numerous stumps, made navigation of any sort difficult.

**Bed 2** – This area barely qualified as a bed as there were native plants mixed in, and the CLP was only intermittently canopied. Average rake fullness varied widely from 1-3; especially on the west side of the bed. The river channel provided navigation through the area and the shoreline was largely undeveloped likely making this a lower priority for control.

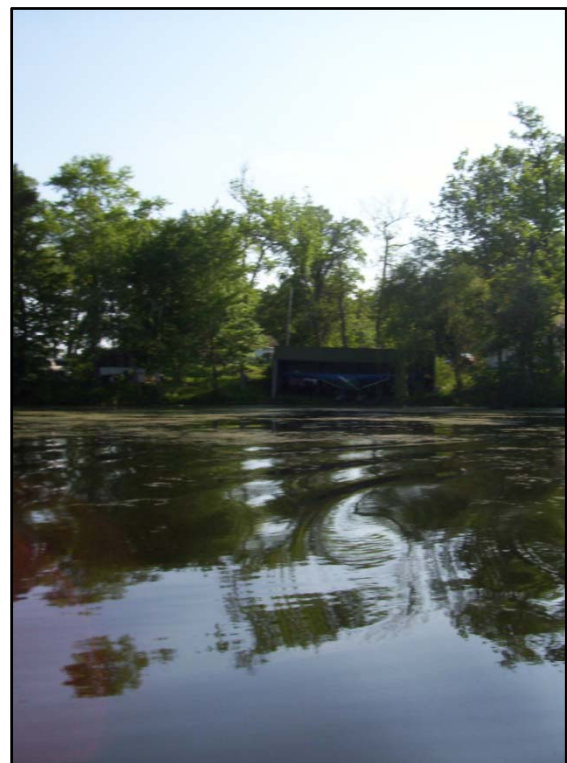
**Figure 6: The Narrows – CLP Beds 3-8**

**Bed 3** – Running the entire length of the western shoreline of the Narrows, the bed was dense, monotypic and canopied out to 8ft of water. We noted that, with the exception of Coontail, native plants were almost entirely excluded from the area. The bed was generally <50m wide making it an inconvenience to access the channel, but crossing it could be done after clearing the prop 1-2 times. Notable exceptions to this were the extreme north and south bays where we had a hard time imagining how the float plane based there would be able to escape for takeoff (Figure 6).

**Bed 4** – This bed was also dense, but we found that it had numbers and diversity of native plants mix in on the eastern border where it wrapped around the small stump islands. The shoreline adjacent to this bed is undeveloped and the area is littered with stumps resulting in the bed likely being avoided by most people.

**Bed 5** – Similar to Bed 3, Bed 5 runs the length of the Narrows. Although more fragmented on the south where it mixes with native species, the CLP becomes continuously denser and more monotypic until becoming a solid bed that stretches over 100m from shore in many places on the northern end. Navigation through the area is extremely difficult and repeated motor clearing is required to transect the bed which likely makes it a major inconvenience for the many residences along this shoreline.

**Beds 6 – 8** – These three small beds were located in front of residences just off the channel in the Cameron Bridge area. Although monotypic and dense, the short distance between them and the navigational channel likely made them only a minor inconvenience.

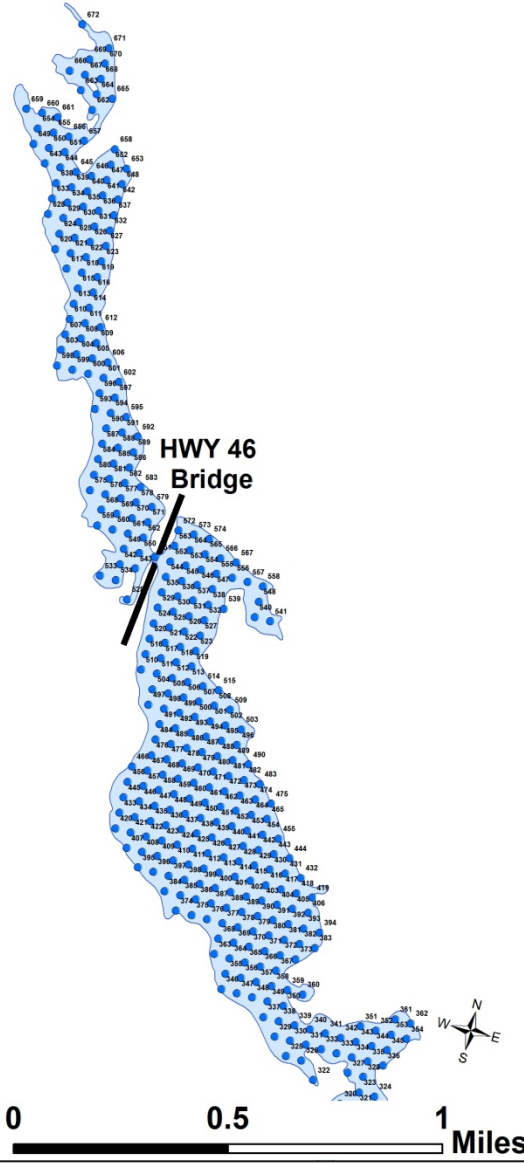
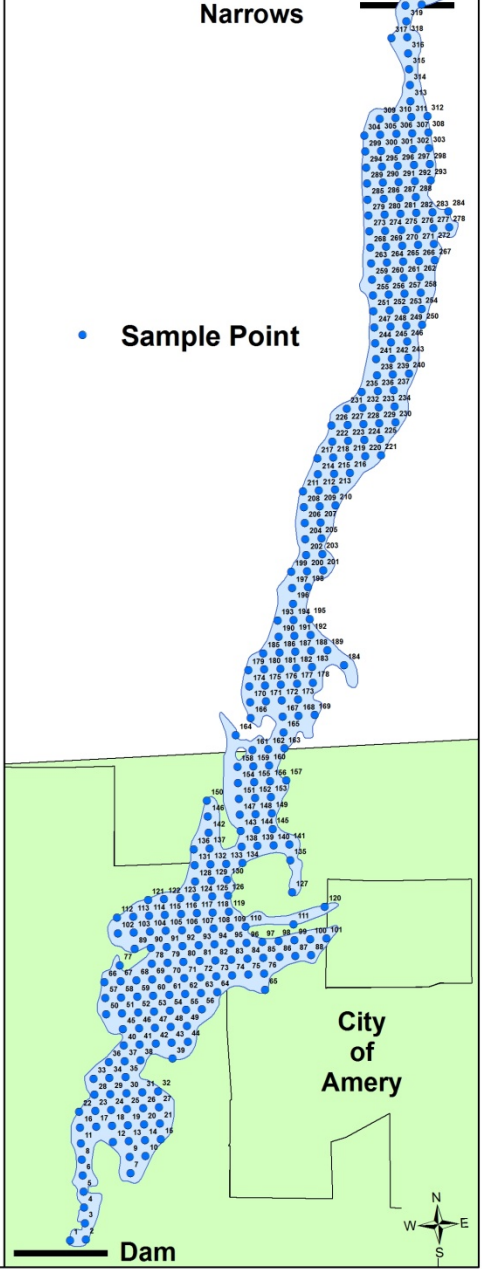
**Appendix I: Apple River Flowage Map with Survey Sample Points**

**Survey Sample Points**  
**Apple River Flowage**  
**Polk County, WI**  
**July 10-12, 2010**

Using a standard formula that takes into account the shoreline shape and distance, islands, water clarity, depth and total acreage, Michelle Nault (WDNR) generated a 672 point sampling grid for the Apple River Flowage (Appendix I). Using this grid, we completed a density survey where we recorded the level of CLP at each point in the flowage’s littoral zone. We located each survey point using a handheld mapping GPS unit (Garmin 76CSx), and used a rake to sample an approximately 2.5ft section of the bottom. CLP was assigned a rake fullness value of 1-3 as an estimation of abundance (Figure 2). We also recorded visual sightings of CLP within six feet of the sample point.

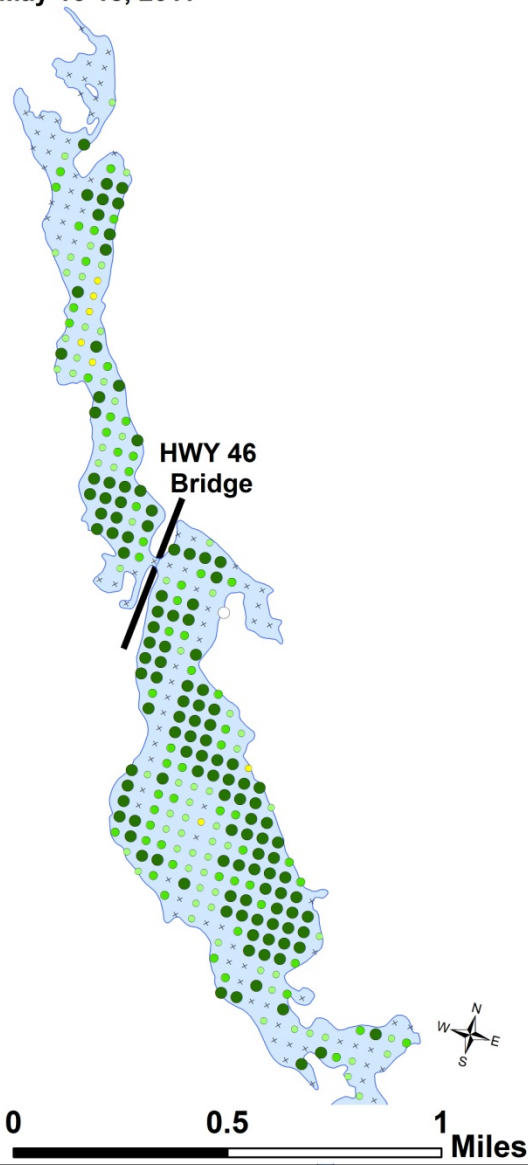
### **Appendix III: Apple River Flowage CLP Distribution and Density**

**Curly-leaf pondweed  
(*Potamogeton crispus*)  
Aquatic Macrophyte Distribution  
Apple River Flowage  
Polk County, WI  
May 16-18, 2011**

We surveyed all 671 accessible points as essentially the entire flowage either falls in or is adjacent to the littoral zone (1 point was terrestrial). We found CLP present in the rake sample at 465 locations and it was recorded as a visual at an additional 9 points (Figure 3) (Appendix III). This extrapolated to CLP being present in approximately 69% of the flowage. Of these points, 232 had a rake fullness rating of 3 and another 116 rated a 2 indicating 52% of the flowage had a significant infestation. Although found throughout the littoral zone, CLP achieved its greatest densities in sheltered bays with muck bottoms in water 3-7ft deep. In general, the only place CLP wasn't found was in the deepest parts of the river channel, in water <1ft deep where Coontail filled the entire water column, and in most of the shallow Northern wild rice (*Zizania palustris*) areas surrounding the Apple River Inlet.
